AIRGAS MERCHANT GASES

Dublin, GA

Improper Adsorber Vessel Filling August 13th, 2018

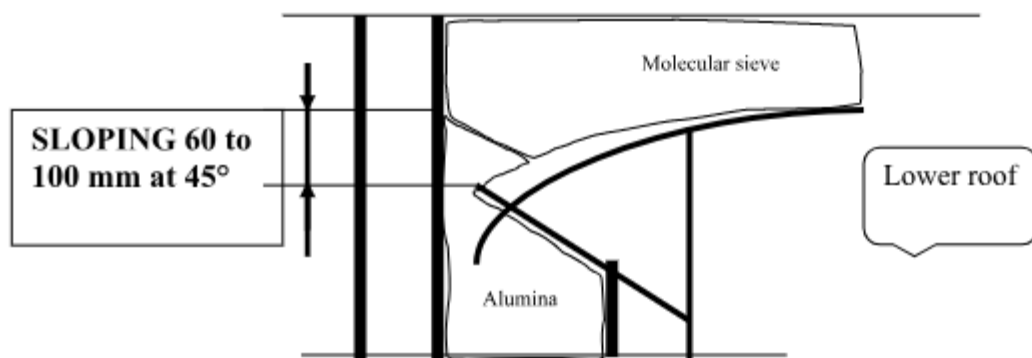
Due to this fact, it's incredibly important to follow the Air Liquide spec. on filling these adsorbers. In it, it explicitly diagrams and notes that the "final top off of alumina should be 60-100 mm at the lower roof." As mentioned, RPS acknowledged the receipt of this spec. and had read through it prior to starting work. The investigation yielded that the contractors violated this requirement and filled above this threshold.

- After noting the level of missing alumina, top-off the required level with a plastic bucket, while sloping the alumina by some 60 to 100 mm at the lower roof, according to the sketch below. Move the alumina accumulated on the roof towards the slope.

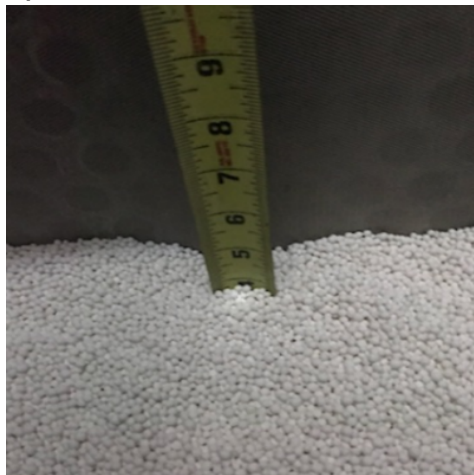
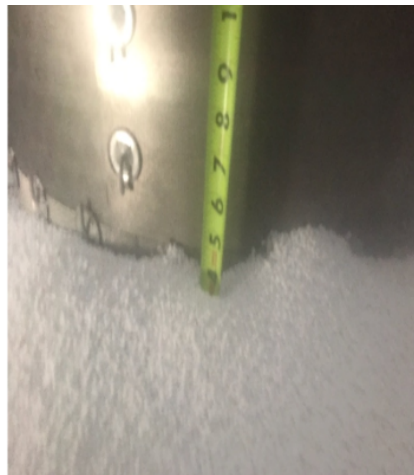
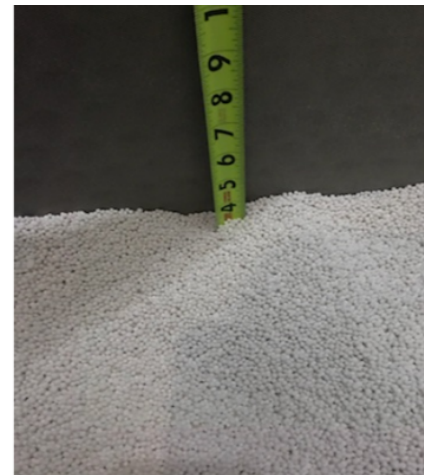
After the completion of work, RPS needed to visually inspect the level in the adsorber before filling the top layer with mol sieve. The confined space team part of RPS did not appropriately validate the height of alumina before proceeding. This was confirmed when the investigation team found that alumina levels in all three beds were overfilled by four inches.

RPS was brought in again and removed the upper mol sieve layer and measured the alumina layer which was found to be above what was required. The team then removed

the additional alumina and eventually emptied the entire vessel. The mol sieve that was removed from the vessel was regenerated and topped off with new Mol sieve to compensate for the handling losses.

Upon receiving regenerated Sieve material and new Alumina, the vessels were recharged and the VSA was restarted and the plant began making the required product purity and hasn't had any issues since July 2018.
